TABS WALL SYSTEMS, LLC

### **CONTROL JOINTS IN ADHERED VENEER INSTALLATIONS**

TABS 2nd Quarter Newsletter

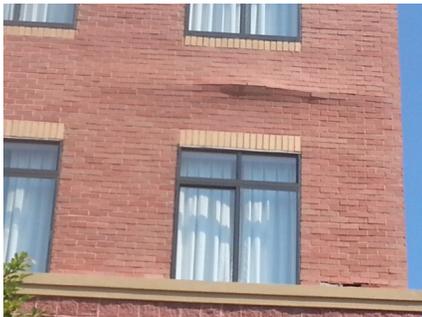
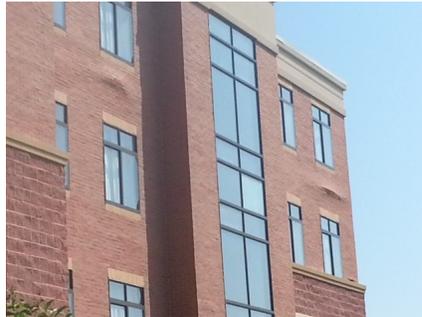
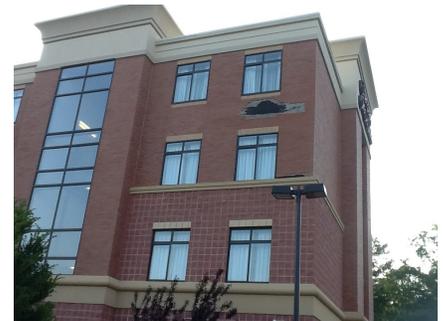
Three years ago, **TABS Wall Systems** received a call from a frantic hotel owner in Richmond, VA. The hotel had thin brick installed with a lath system. As visible in the photos, the walls were literally buckling.

The cause was apparent immediately. No site visit was necessary. There was not a single control joint anywhere on the building. The only “soft joints” were at the windows.

Projected (non-union) costs for labor to remove, dispose of and replace the thin brick installation were \$35 per square foot. Replacement materials were estimated at \$7 per square foot. Thus the 10,000 square foot façade costs were approaching \$500,000!
