Revisiting Wood Framing

September 5, 019

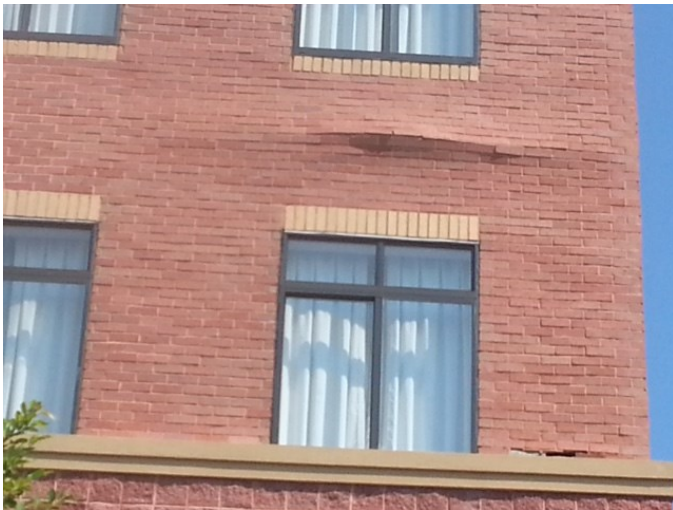
Floor Line Buckling Due to absence of control Joint

3. Provide control joints at **every** floor line to reduce the incidence of buckling due to restriction of movement and live loading.
4. Provide control joints both sides of outside building corners within 2'. **TABS** has noted no issues with differential and/or shrinkage-expansion movement at these locations when there are control joints at 2' from corners. (This is a change from 2017 when we recommended 2-4' at outside corners)

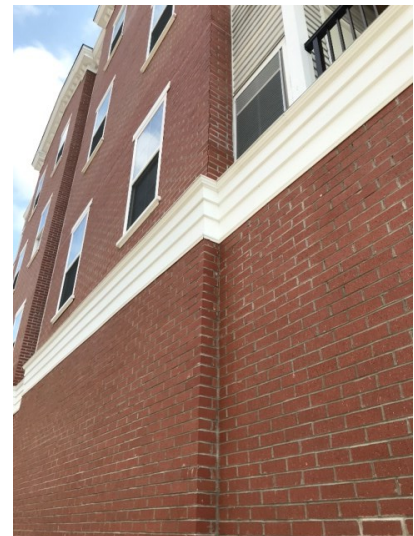
Corner Cracking at upper floors with wood framing; no cracking at 1st floor with steel framing

5. Install **TABS'** pre-bent corner panels at all outside corners. Combined with control placement, the **TABS'** structural steel panels actually reinforce building corners. Thus, cracking of thin veneer corner units is extremely rare.
