TABS WALL SYSTEMS, LLC

### **CONTROL JOINTS IN ADHERED VENEER INSTALLATIONS**

TABS 2nd Quarter Newsletter

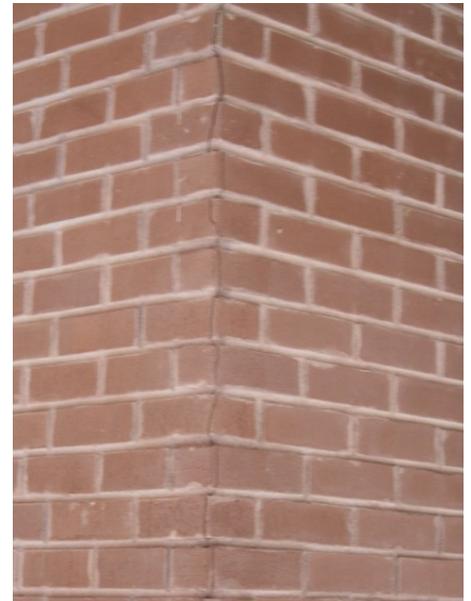
Outside corners on wood framing are particularly problematic. In addition to differential movement, wood framing experiences shrinkage, swelling, bending, cupping and twisting (See [TABS 2017 3<sup>rd</sup>/4<sup>th</sup> Quarter Newsletter](#)). The result of inadequate accommodation of conditions in wood stud framing can be random cracking of the corner brick units.
